JT9D Performance Deterioration Results from a Simulated Aerodynamic Load Test

Edward G. Stakolich
Lewis Research Center
Cleveland, Ohio
and
William J. Stromberg
Pratt and Whitney Aircraft Group
United Technology Corporation
East Hartford, Connecticut

Prepared for the Seventeenth Joint Propulsion Conference cosponsored by the AIAA, SAE, and ASME Colorado Springs, Colorado, July 27-29, 1981

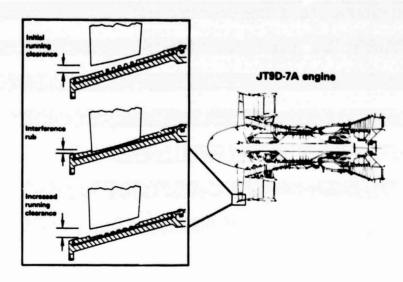
and inertia loads on the engine which occur during flight. These deformations cause rubbing of the rotating blade tips on their outer air seals (Fig. 1) which produce the increased clearances reducing the efficiency of the engine.

Figure 1. - Effect of aerodynamic flight loads on fan blade tip clearance.

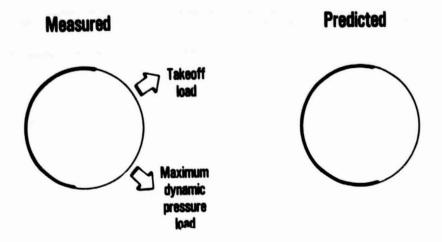
Fan outer airseal (looking forward)

Seal land wear patterns observed during the teardown of the test engine are shown in Fig. 14 for the fan. The locations of wear were as expected. Wear in the upper left quadrant was produced by the maximum dynamic pressure air load which pulled the fan case down and to the right. The take-off air load pulled the fan case up to the right and produced wear in the lower left quadrant of the fan outer air seal.

Figure 14. - Predicted versus measured outer seal wear patterns produced by flight loads.
